TECHNICAL BULLETIN 2.0

SC1 & SC2 Splice Coupler

July 2024

SPLICE COUPLER PLACEMENT DURING INSTALLATION

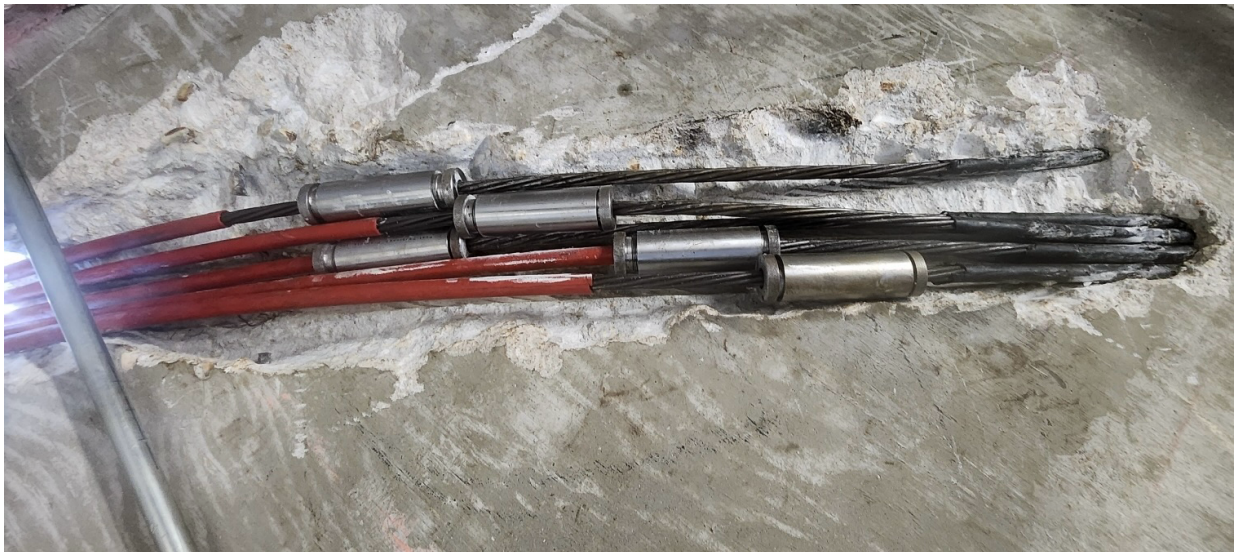
Placement within a lateral tendon sweep

This problem occurs during the repair of tendons that have ruptured from a slab as the result of insufficient hairpin reinforcement. Some installers find it tempting to make the repair within the existing damaged area of the slab, where the tendons are making a lateral directional change. It is strongly recommended to avoid the installation of splices within an area of lateral tendon displacement, instead they should be located in areas where the tendons have returned to a straight configuration.
