TECHNICAL BULLETIN

Post Tensioned Structural Repairs

THE IMPORTANCE OF CONCRETE PREP GEOMETRY FOR POST-TENSION REPAIR

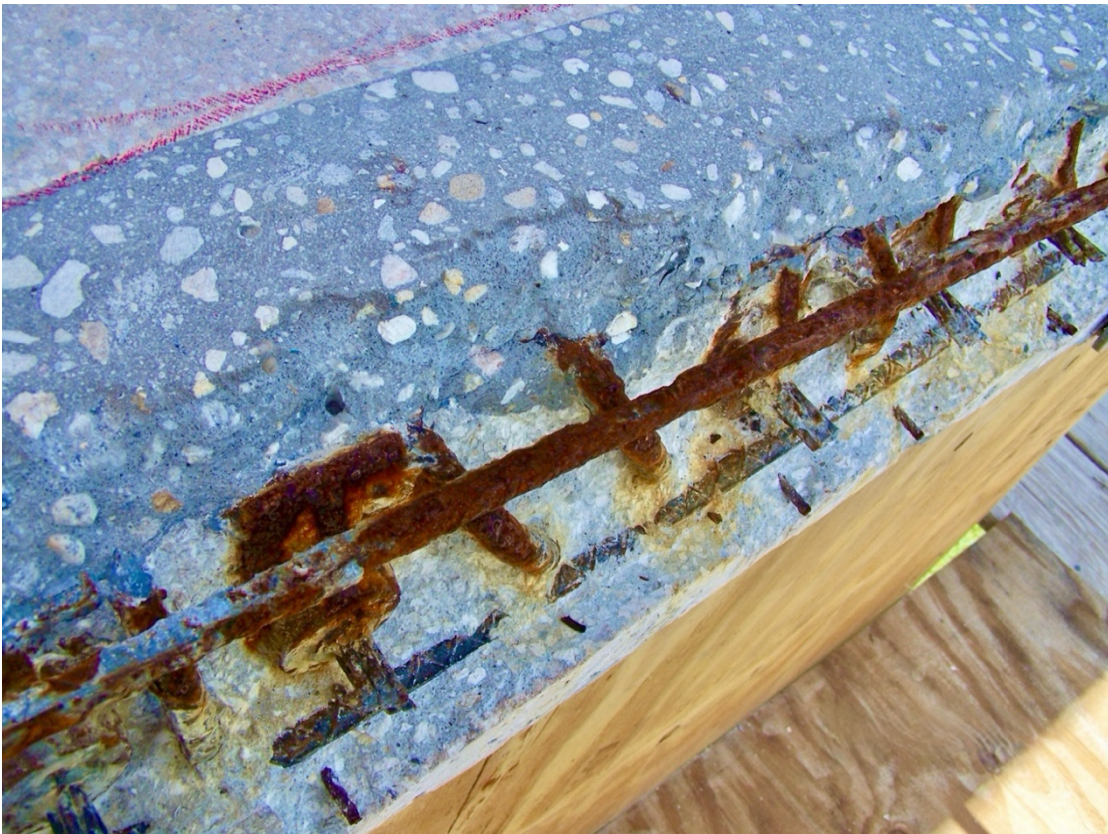
Photo: Old patching material is clearly visible, exposing advanced corrosion of embedded steel.

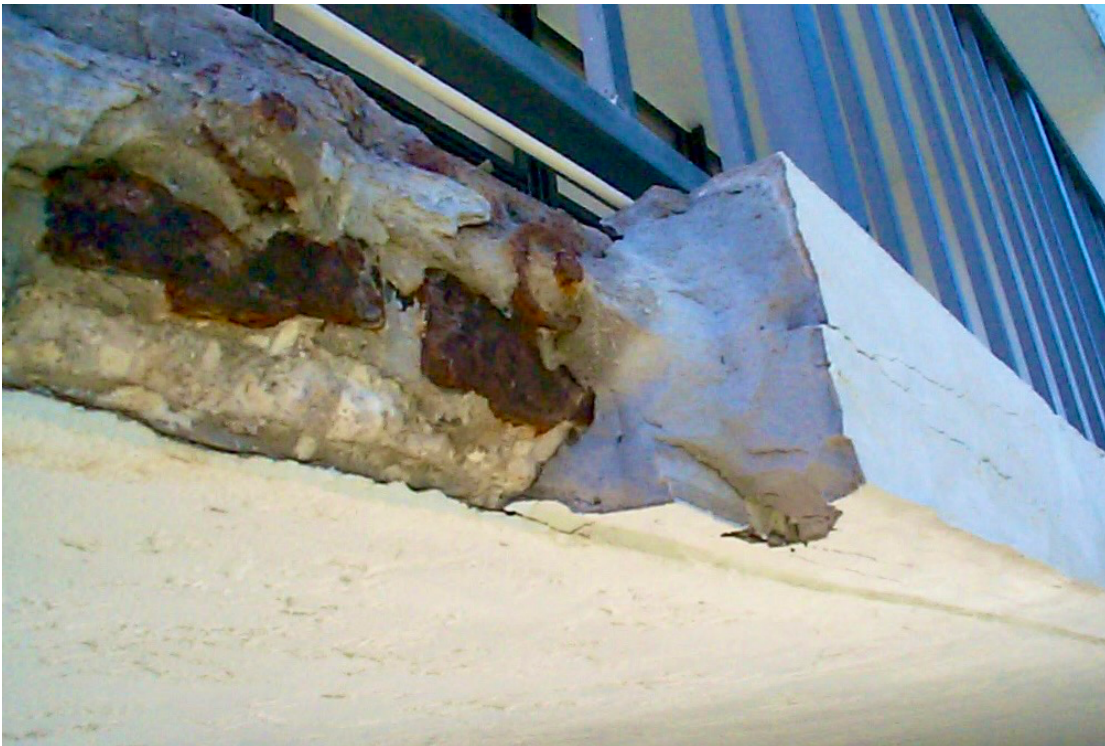
When corrosion damaged concrete is removed only from the face of the anchors and surrounding rebar, this causes the embedded steel elements to become sandwiched between the existing concrete that remains and the new concrete patching mortar. The resulting extreme differential between the properties of the two concrete materials creates a macroscopic corrosion cell with increased corrosion potential that causes the embedded steel to continue to corrode at a rapid rate. The International Concrete Repair Institute (ICRI) describes this phenomenon as the Anodic Ring or Halo Effect. They attribute this accelerated corrosion to the differential in electrical potential that's created "between the chloride contaminated or low pH existing concrete and the chloride-free or high pH repair material".

Photo: This failed slab edge patch was applied to the surface of the anchors without fully excavating the damaged area.

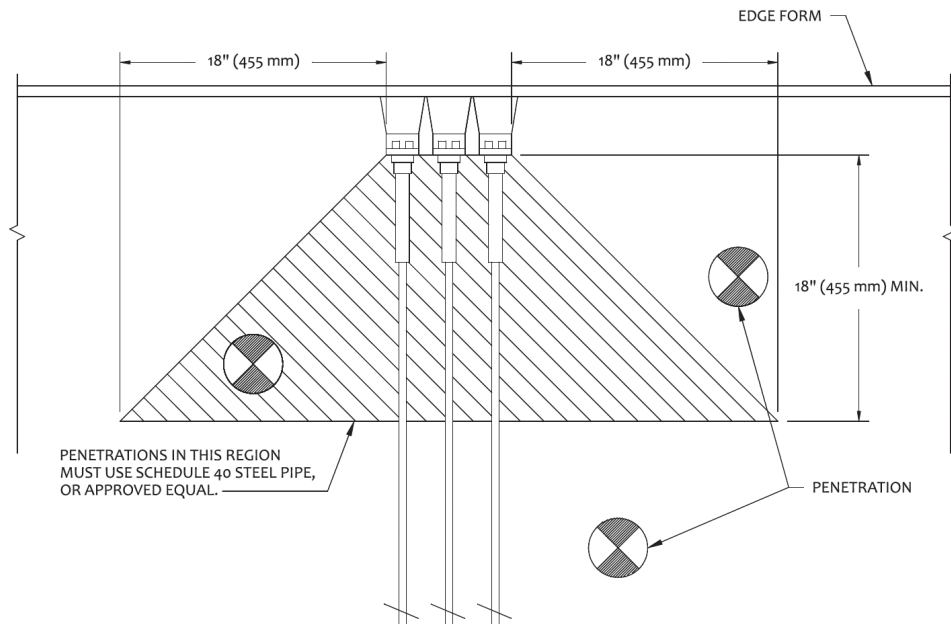
Fig. 4-5—Penetrations near tendon anchorage zone.

Image: The Post-Tensioning Institute recognizes the high-stress zone that exists behind terminal anchors.

When corrosion damage extends into the mild steel reinforcement located around and behind the tendon anchors, the concrete repair excavation protocol recommended by the ICRI can require the removal of concrete into the high-stress zone that exists behind the tendon terminal anchors. Therefore, in order to perform this work safely, the tension load on existing anchors must be temporarily relocated using a specialty lock-off anchor that is installed beyond the high-stress zone.

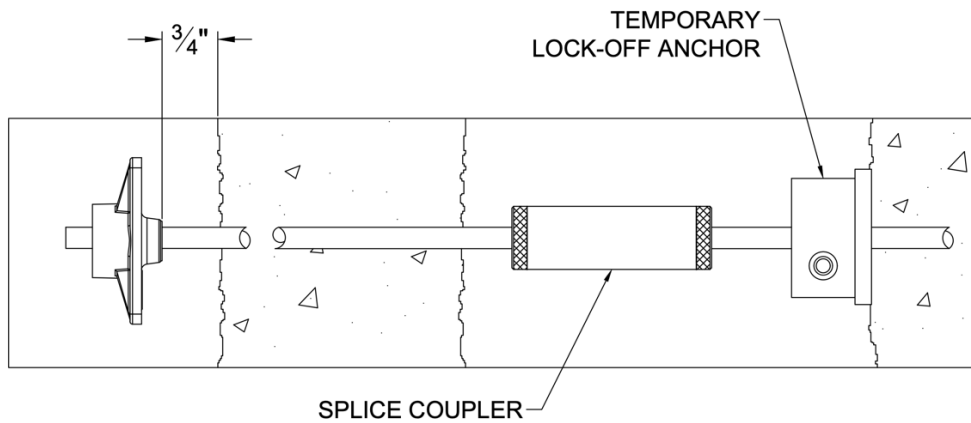
Image: Note that the ICRI required excavation extends into the high-stress zone behind the anchor.

When performing concrete structural repairs, the ICRI *“Guide for Surface Preparation for the Repair of Deteriorated Concrete Resulting from Reinforcing Steel Corrosion”* recommends a “minimum of 0.75 in. (19 mm) clearance between exposed reinforcing steel and surrounding concrete or 0.25 in. (6 mm) larger than the coarse aggregate in the repair material, whichever is greater.”

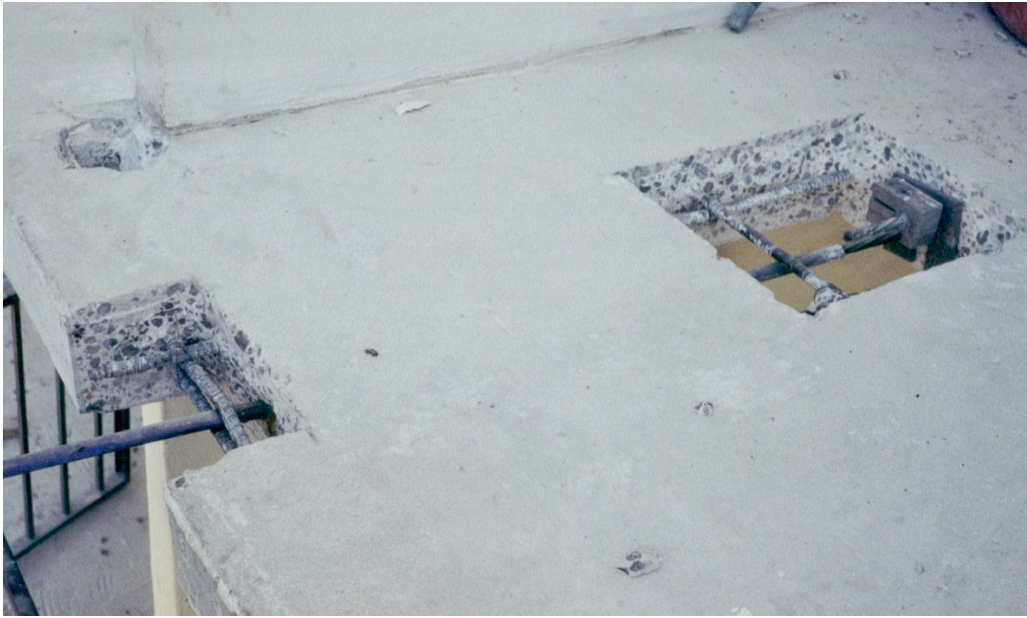
Photo: Shown is a fully excavated slab edge per ICRI requirements with tendon lock-off installed.

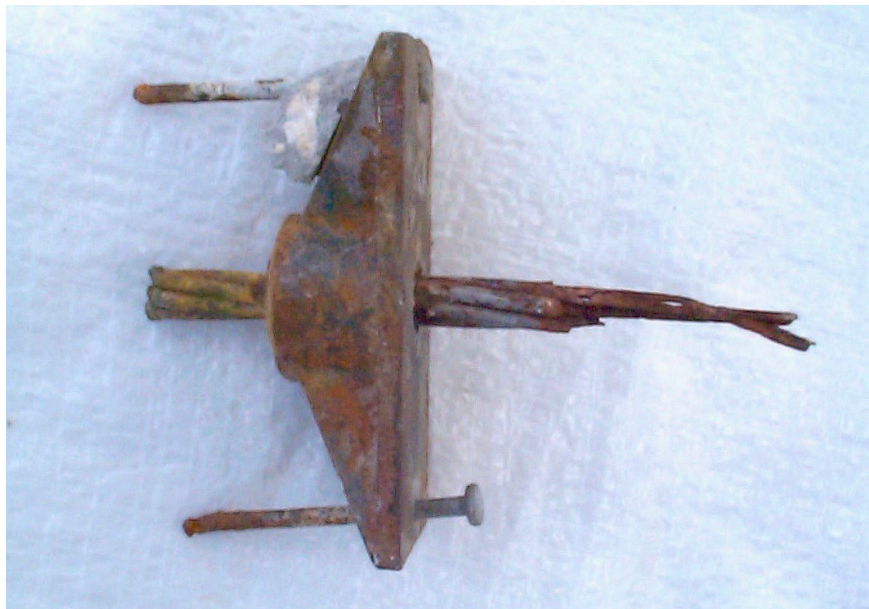
Ongoing corrosion of embedded mild steel around the post-tension anchorages will result in cracking and spalling of the concrete coverage in this critical area. These cracks will permit water to penetrate deeply into the slab and down to the level of the post-tensioning, which can find its way directly into the cables through any disruptions in the tendon sheathing. When this is allowed to happen, it substantially increases the likelihood of corrosion of the steel cable and can ultimately result in a failure of the tendon.

Photo: Tendon end that shows cable corrosion due to water intrusion into the cable sheathing.
