# EZ PLACE CABLE RAIL STRENGTH ANALYSIS - REV 1 (Includes Test Results)

This report is an update to SEP’s previous report of 3-20-24 and is issue for the following purposes:

**CRVH-001**  
EZPLACE CABLE RAIL - HIGH IMPACT  
90 DEGREE

RE: WFG Rail Pull Test P/N AC1318-19.  
Test Performed 07/02/24

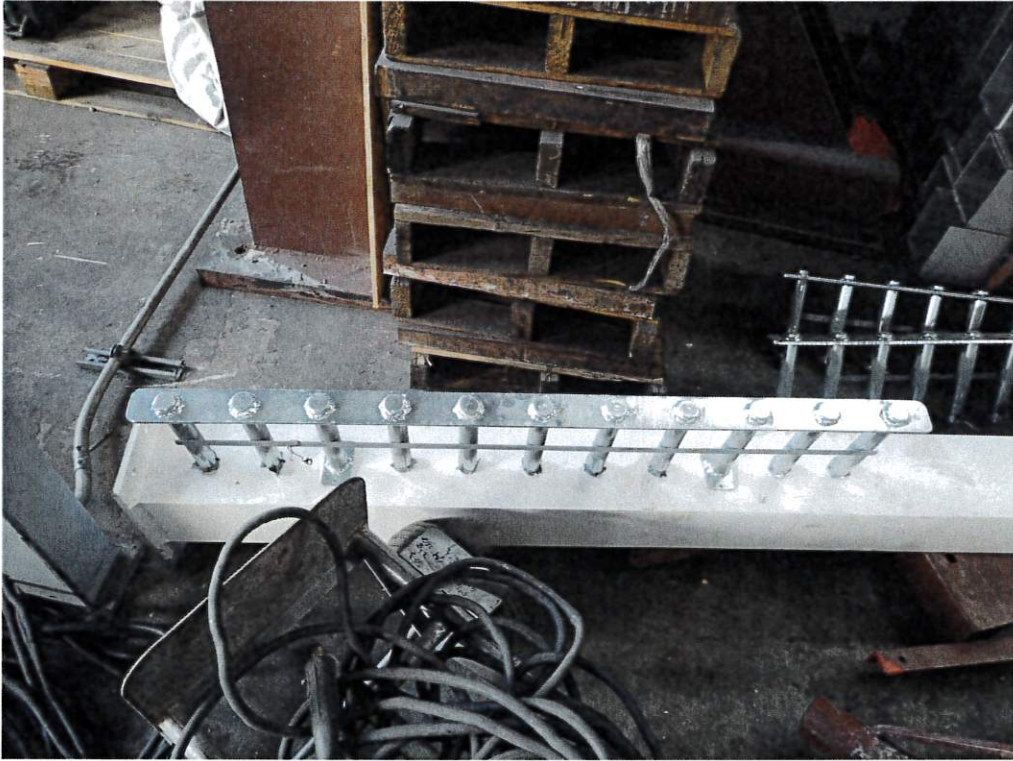
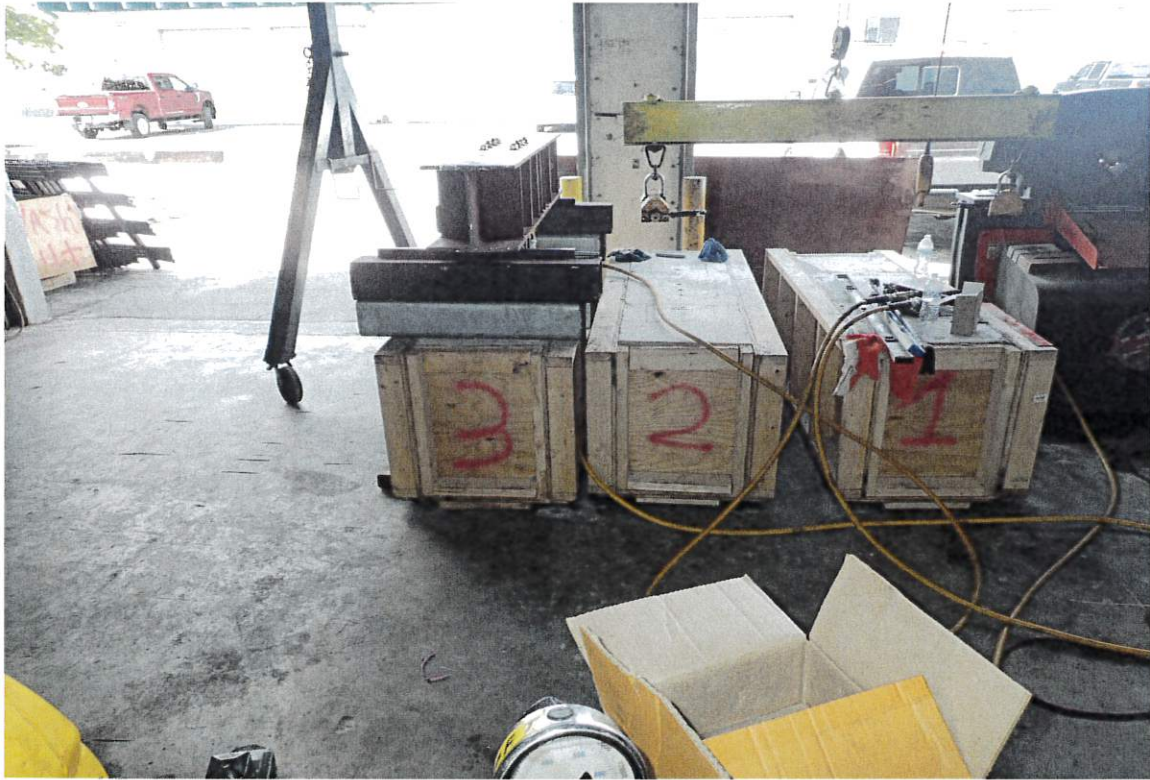
This summary is for load testing to failure of WFG Rail P/N AC1318-19. Three concrete enclosures were fabricated to encase WFG Rail Assembly, 24" x 24" x 60" with 6,500 PSI cement mix and cured for six days prior to testing. See Figures 1-3. A fabricated steel I-Beam for a cross-head was used; connecting eight threaded 3/4"-B7 rods to 1/2" steel plate with three Grade 8, 3/4" bolts torqued to 104 ft/lbs. inserted to WFG Rail Assembly. See Figures 4-10. Two hydraulic 30 ton jacks were used under cross-head to produce a tension load on the WFG rail assembly. Power was applied to Enerpac Pump/Gauge and Jacks to give an indicated 1,000 PSI on pressure gauge producing a PSI stress load of approximately 22,000 on all samples. See Figures 11-16.

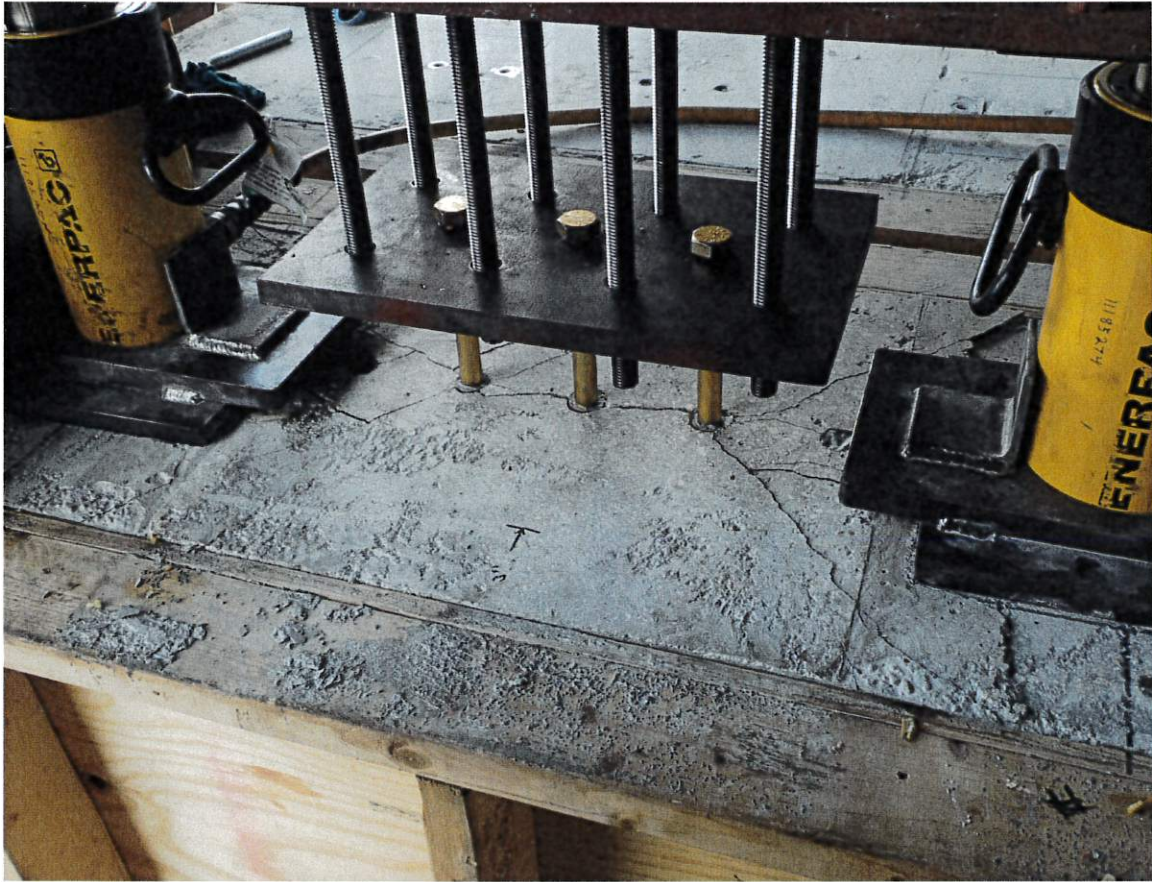
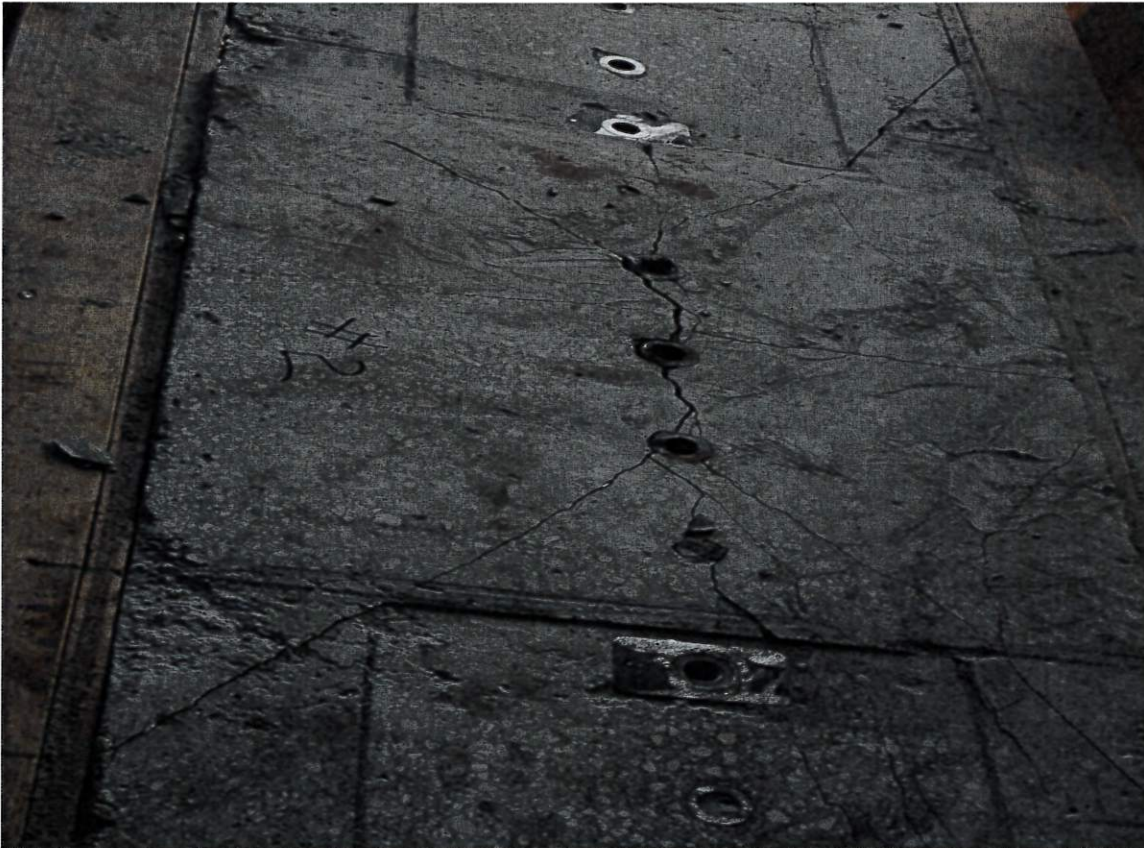
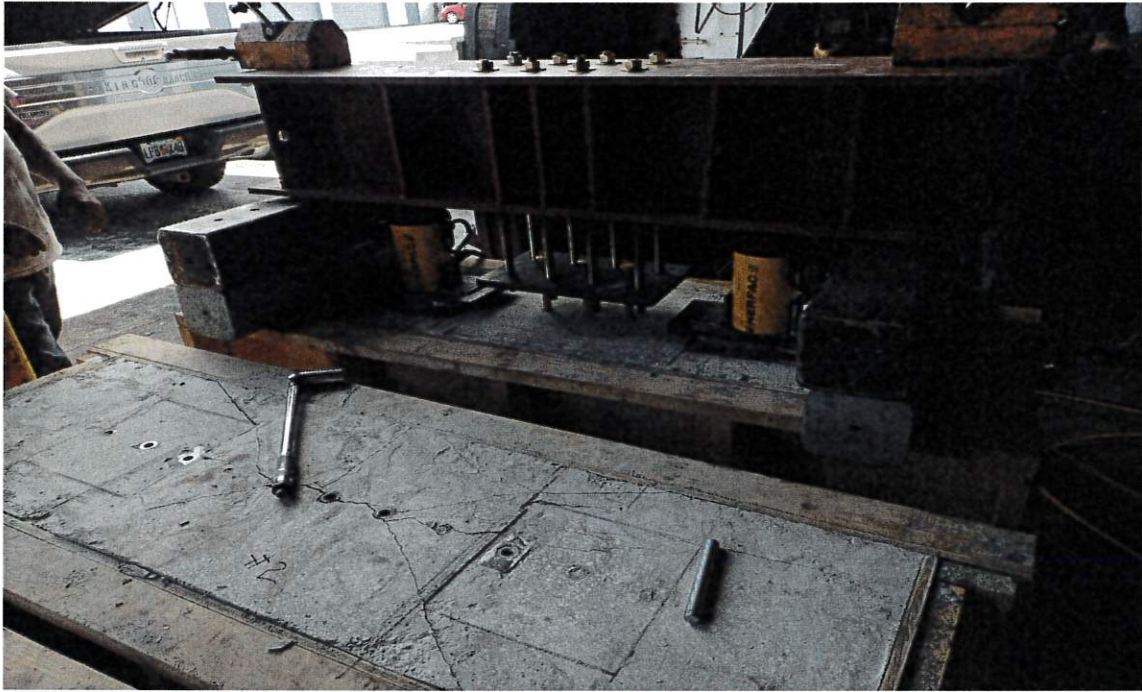
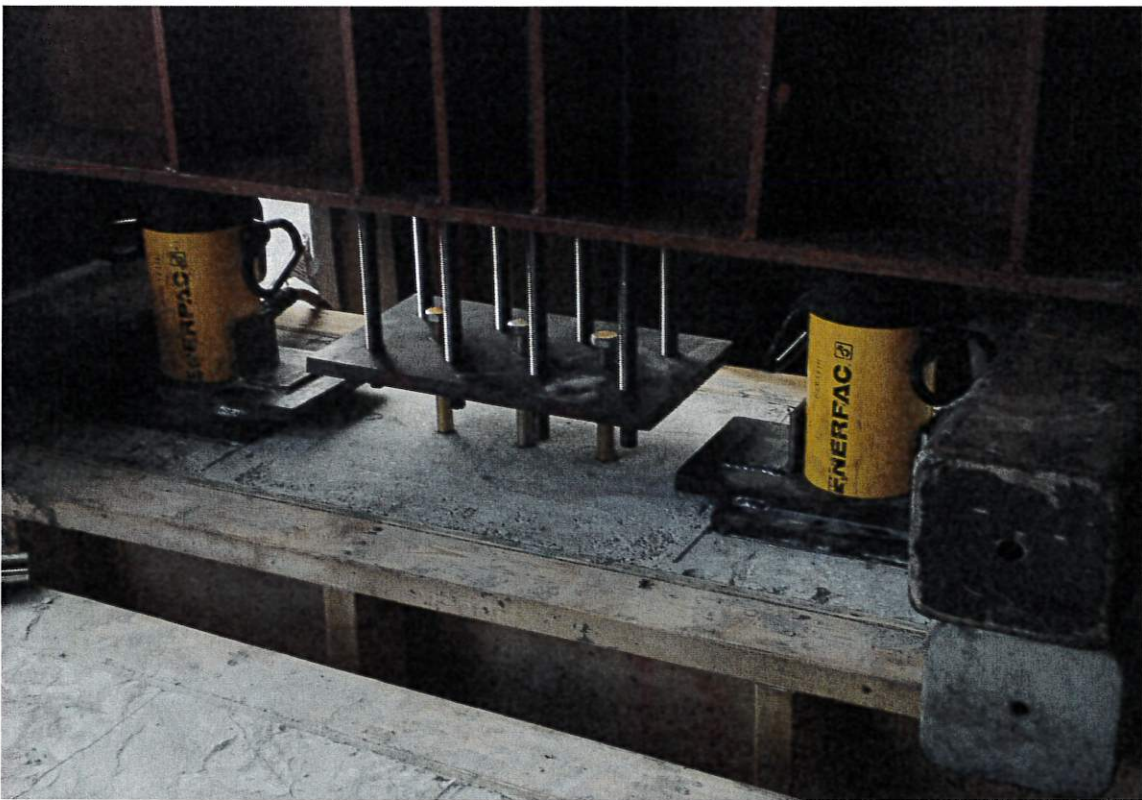
Power was applied to an estimated rate of .5 in/min C/H speed until maximum value achieved on pressure gauge when pressure drops indicating failure load. Procedure was performed on all three samples showing failure mode. See Figures 17-22.

The rail assembly itself was bent (See pictures). This is because the rail assembly was being held down on its ends by the test fixture.

It was also noted that the rail assembly was bent just outboard of the three center inserts when the testing was done. The raw test results indicate that the rail assembly sustained a test load of 131.0 Kips before failure. However, this load also included some “overage” due to the fact that we were holding the rail assembly down at it’s ends at the same time. We therefore attempted to adjust for this “overload” by estimating how much load it took to bend the rail assembly as was observed in the
